File Number: 2012_032
Date: November 9, 2012

SEATTLE PUBLIC UTILITIES NOTICE OF VIOLATION AND ORDER FOR CORRECTIVE ACTION AND PENALTY

Name: Rainier Commons LLC
Attn: Vered Mizrahi

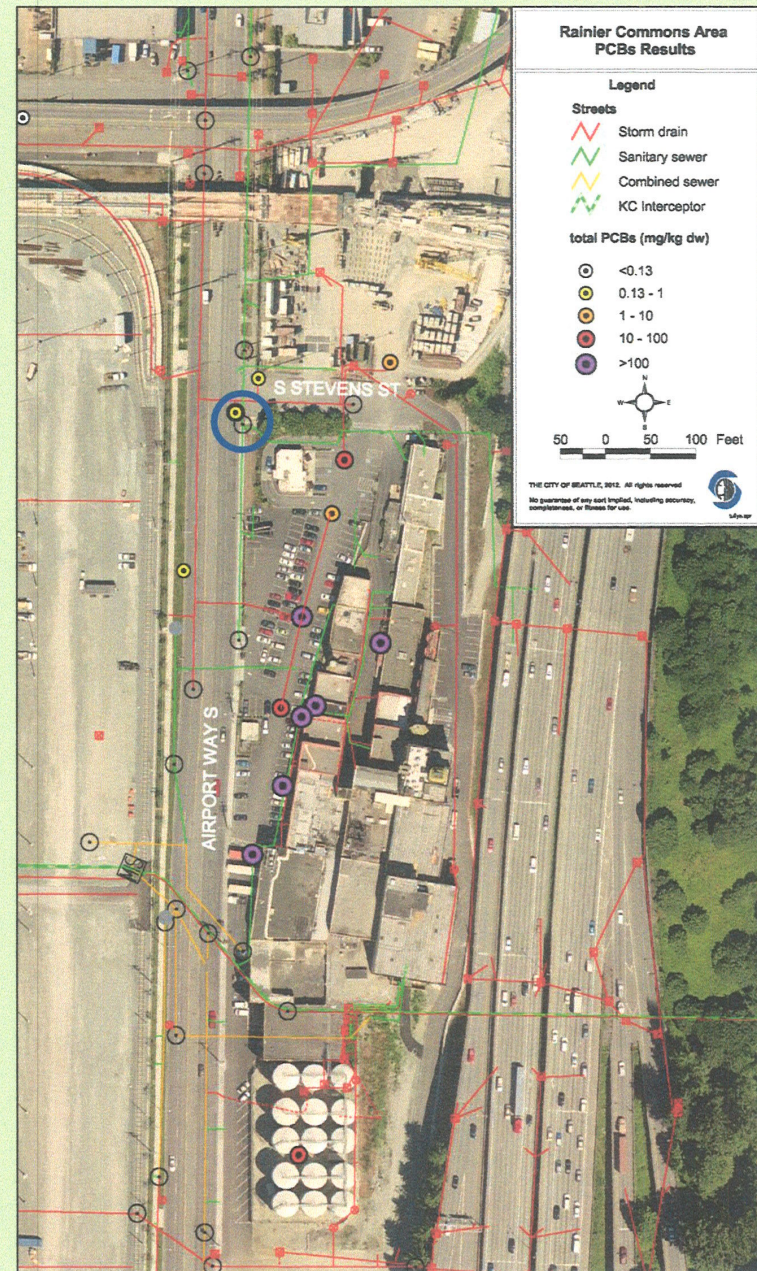
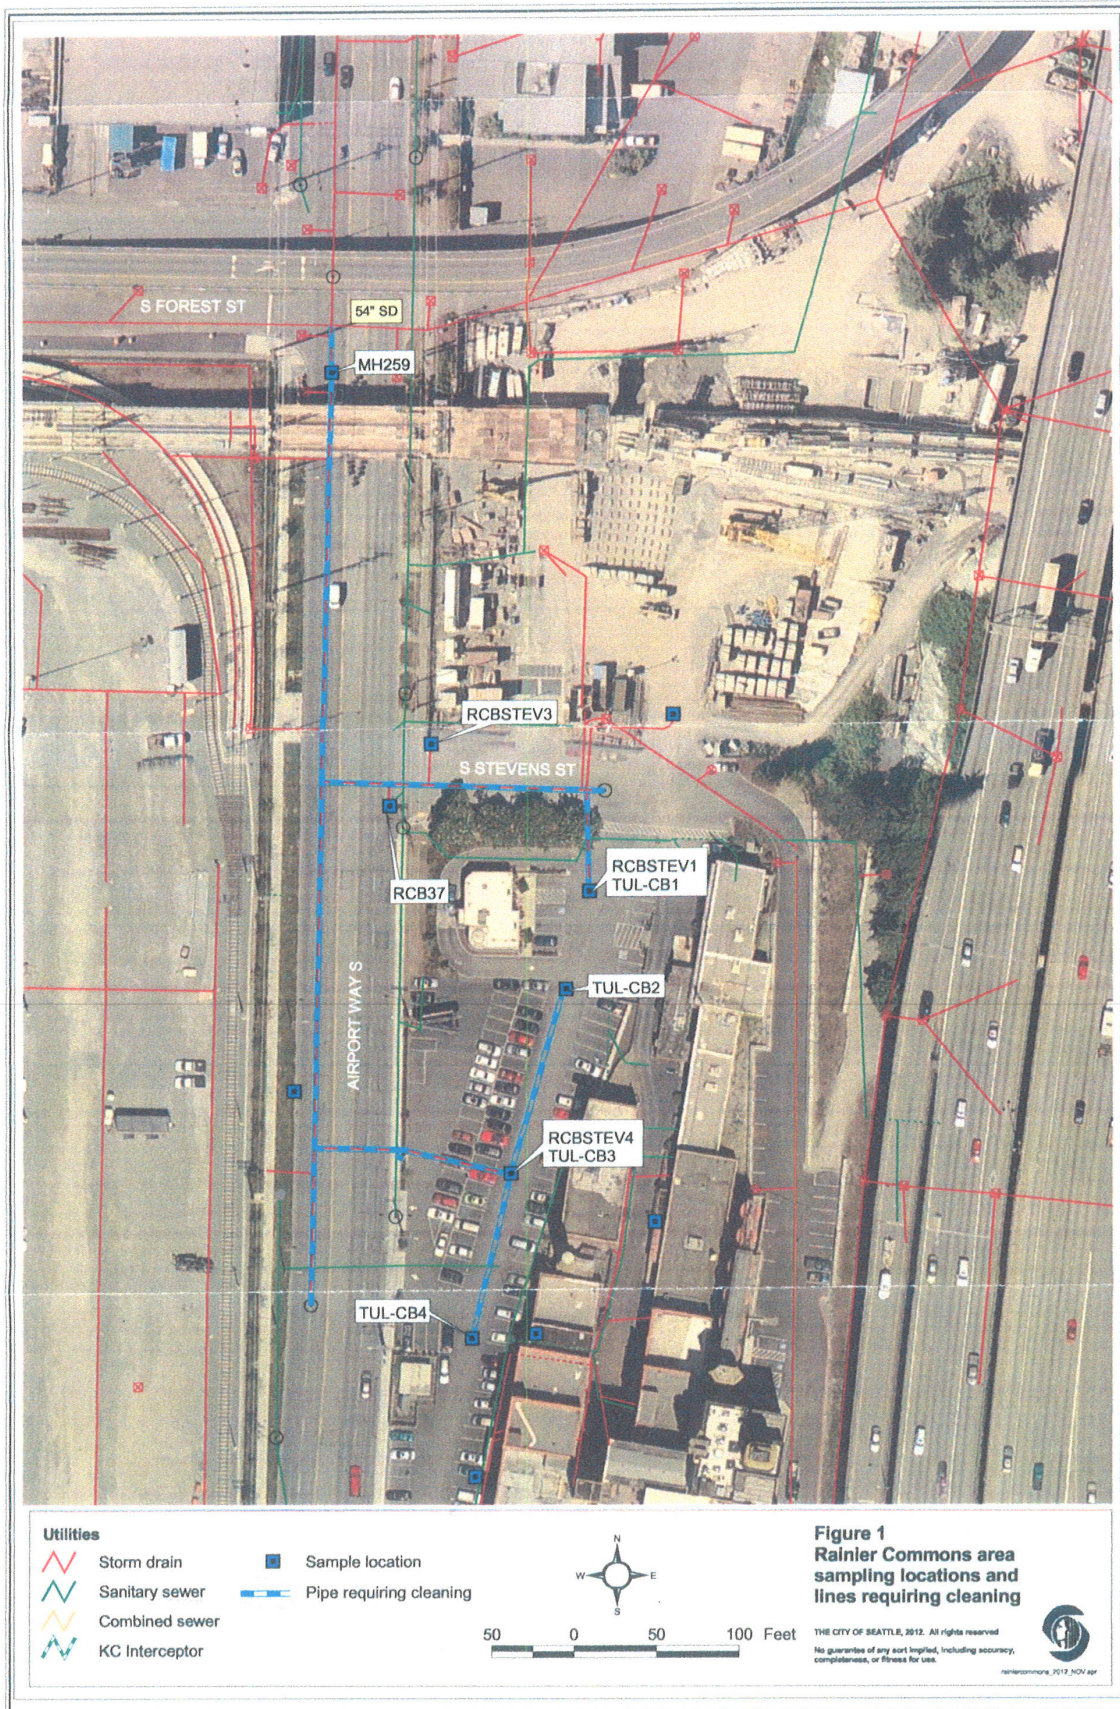
Old Brewery

PCBs in building paint

- 2004: Found 10 mg/kg PCBs in ROW catch basin
- 20,000 mg/kg in exterior building paint
- EPA TSCA site
- SPU jetted and cleaned lines
- Owner installed filter fabric in CBs
- Owner pilot testing paint removal techniques

In late 2005, SPU conducted a stormwater pollution prevention inspection of Rainier Commons. As a result of this inspection, SPU sent a corrective action letter dated November 22, 2005 that required cleaning of all catch basins located on site. Additionally, the corrective action letter requested that Rainier Commons investigate their property for the source of the PCBs found in the catch basins. Subsequent investigation discovered that the exterior surface of many of the buildings located on this property had been painted with a coating containing high levels of PCB and was the likely source of PCB in the catch basins.
